DJI\_20221217135929\_0014\_T.JPG

2022/12/17 13:59:29

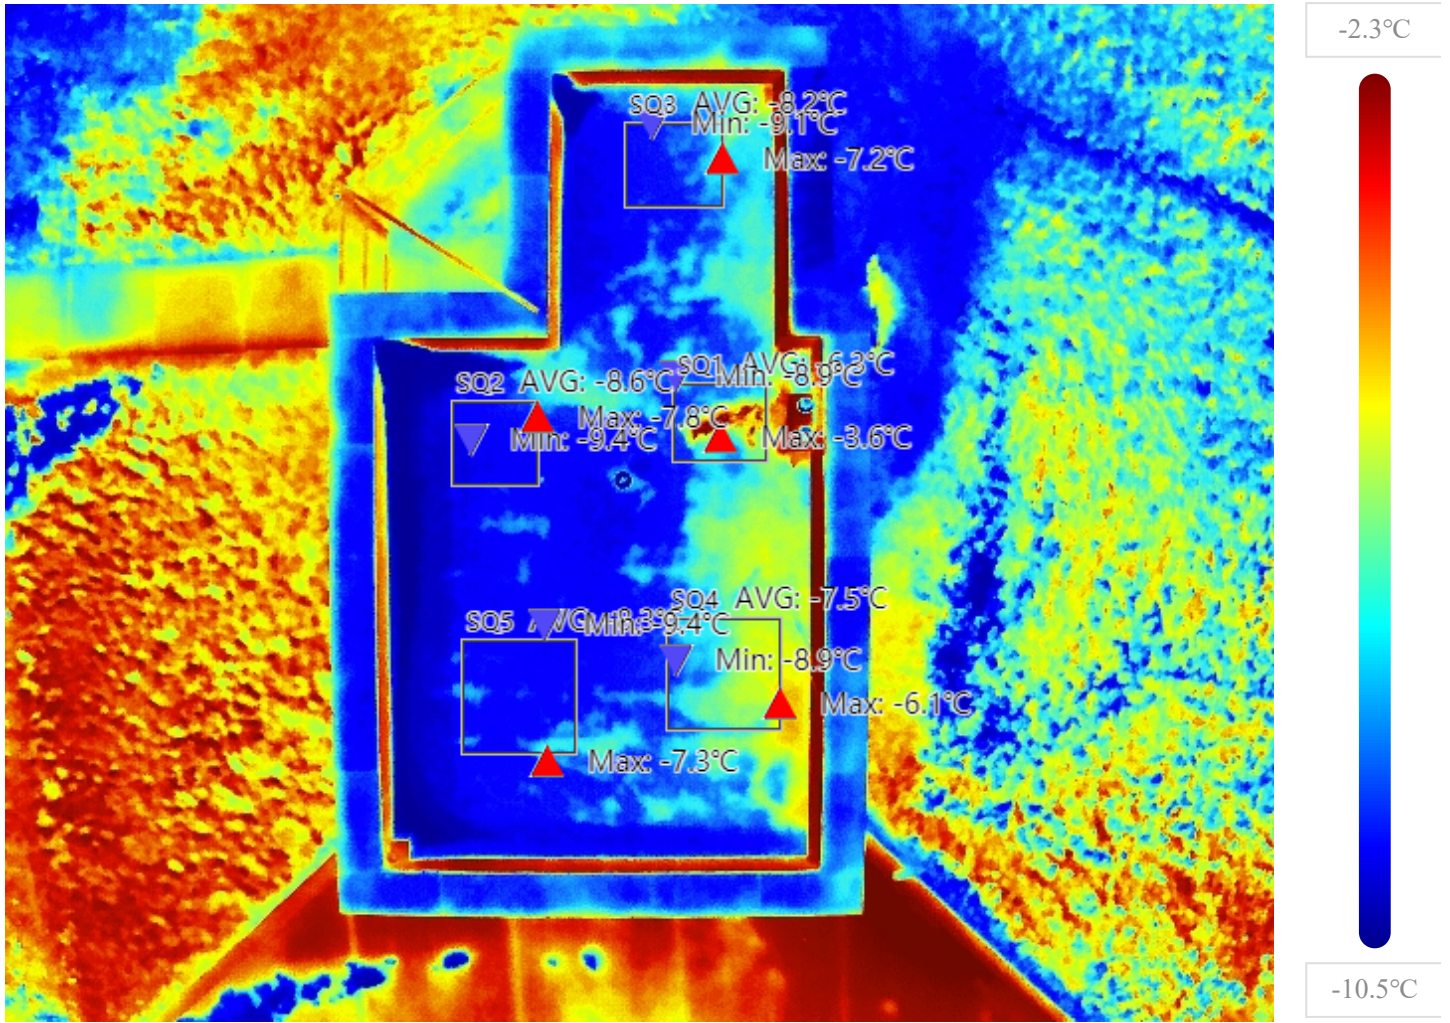
SQ1	MIN	-8.9°C
	AVERAGE	-6.3°C
	MAX	-3.6°C
SQ2	MIN	-9.4°C
	AVERAGE	-8.6°C
	MAX	-7.8°C
SQ3	MIN	-9.1°C
	AVERAGE	-8.2°C
	MAX	-7.2°C

SQ4	MIN	-8.9°C
	AVERAGE	-7.5°C
	MAX	-6.1°C
SQ5	MIN	-9.4°C
	AVERAGE	-8.3°C
	MAX	-7.3°C

Disturbed/damaged asphalt creating hotspot. SQ1 shows -3.6C, which is on average 3.5C warmer than the SQ2-5. The hot spot could indicate roof damage and a point of penetration.
